Shimadzu Industrial Systems Co., Ltd.

### **Incident Reports and Urgent Safety Notice for Hydrogen-Operated Industrial Furnaces**

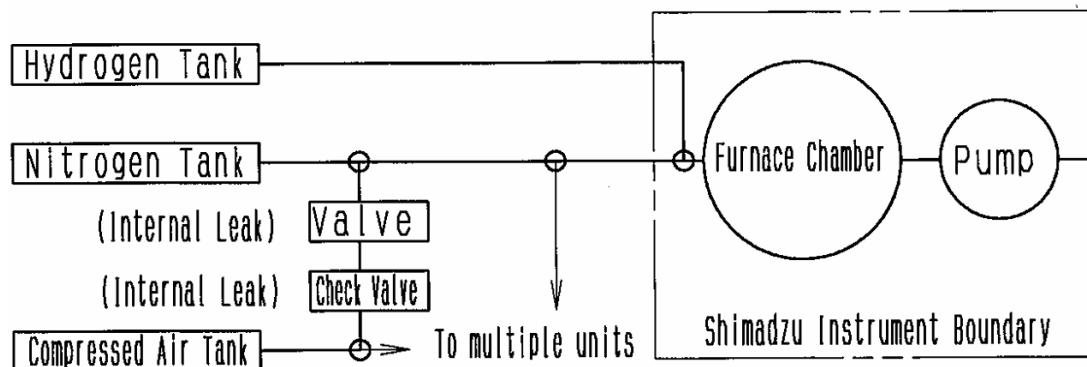
Figure 1. System Schematic at the Time of the Incident

In a hydrogen-operated furnace, the chamber was evacuated and repressurized with nitrogen prior to introducing hydrogen for heat treatment. Upon starting the process, abnormal combustion occurred, causing damage to the internal carbon components.

The customer's compressed air piping and nitrogen piping were physically connected, and internal leakage occurred in a check valve and a valve installed at this connection point. Consequently, the compressed air bled into the nitrogen supply, and the oxygen concentration inside the furnace is presumed to have increased during repressurization.

- (1) Gas piping for nitrogen, compressed air, and hydrogen must be installed as independent lines and connected to their designated ports.**  
—(Note) Incorrect connections or leaks can result in oxygen contamination or the formation of a flammable atmosphere, causing fire or explosion.
- (2) Clearly label the gas type, flow direction, and operating pressure range on all gas piping, and perform periodic leak tests.**
- (3) Always perform a leak test (e.g., soap bubble test, leak detector, or pressure hold test) after gas replacement or piping modification.**
- (4) We recommend a purity of 99.99% or higher for the introduced gases.**
- (5) Please consult Shimadzu in advance if modifications to our instrument are required.**

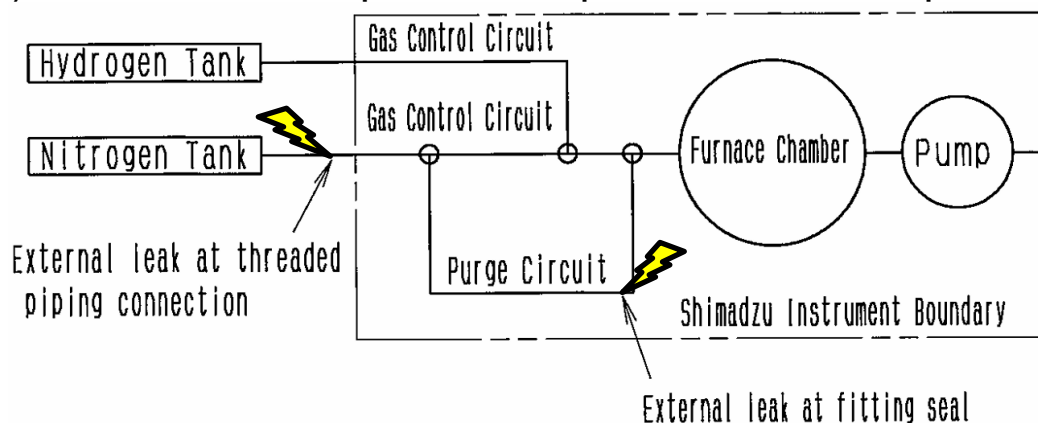
Figure 2. System Schematic at the Time of the Incident

During operation under reduced pressure in a hydrogen-operated industrial furnace, an alarm was triggered, causing the heat treatment cycle to abort. When nitrogen was subsequently introduced to purge the furnace, abnormal combustion occurred, causing damage to the internal carbon components.

An external leak was discovered at the connection point between the customer's nitrogen piping and our supply piping. When nitrogen was introduced while the system was under reduced pressure, the negative pressure generated inside the piping drew in ambient air, which is considered to be the cause. Additionally, the instrument had been relocated, reinstalled, and operated by the customer prior to this incident.

- (1) Please request Shimadzu to perform the relocation and reinstallation of the instrument.
- (2) After gas piping installation, always perform a leak test using methods such as a soap bubble test, a leak detector, or a pressure hold test.
- (3) Establish and execute a periodic leak inspection and maintenance plan.
